City of San Diego  
FY15 Facility Condition Assessment Report for:  
**Facility # 000001 Office. City Administration Building. CAB. Downtown**

**FACILITY EXECUTIVE SUMMARY**

**Facility # 000001 Office. City Administration Building. CAB. Downtown**

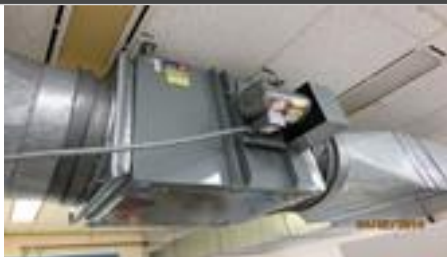
DEFICIENCY REPORT – Building Only							
Year	Priority	Subsystem	Correction	Photo	Location	Funding Type	Cost
2015	Necessary	Distribution Systems	Replace

1965 System	Capital	\$13,580,847
2015	Recommended	Ceiling Finishes	Replace

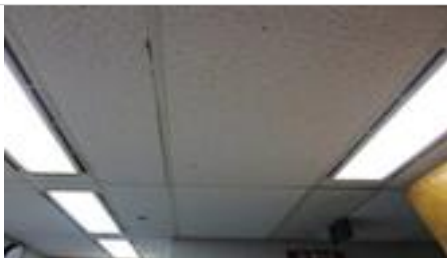
1965 System	Capital	\$11,210,249
2015	Recommended	Floor Finishes	Replace

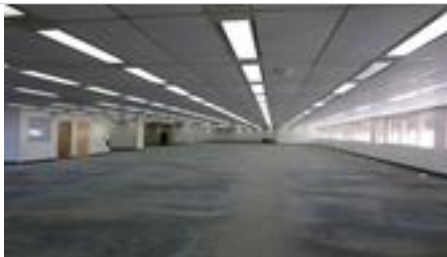
1965 System	Capital	\$7,852,755

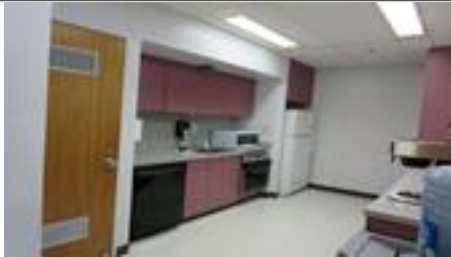
DEFICIENCY REPORT – Building Only							
Year	Priority	Subsystem	Correction	Photo	Location	Funding Type	Cost
2015	Recommended	Other Equipment	Replace

1965 System	Capital	\$337,118
2015	Necessary	Rain Water Drainage	Replace

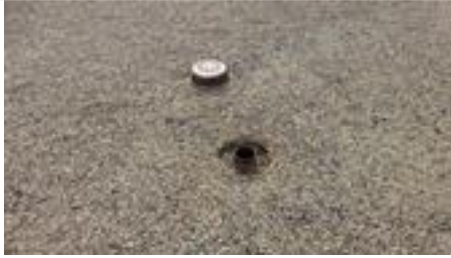
1965 System	Capital	\$293,573
2015	Recommended	Institutional Equipment	Replace

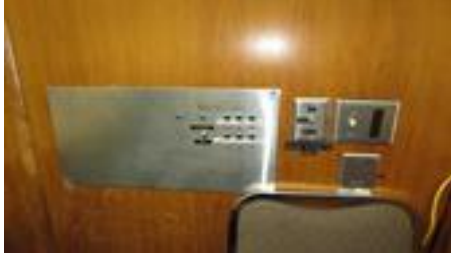
1965 System	Capital	\$232,742

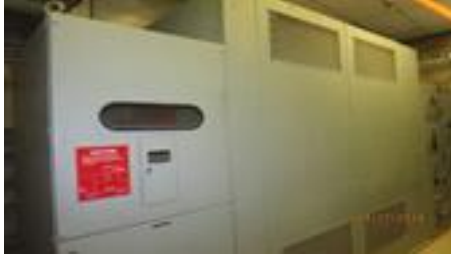
Floor: 9 Room: Office	Maintenance	\$126,360
2015	Potentially Critical	Electrical Service Distribution	Replace

Floor: B1 Room: Electrical Switch Gear ID: 7376736 Type: Electrical Panel	Capital	\$75,897

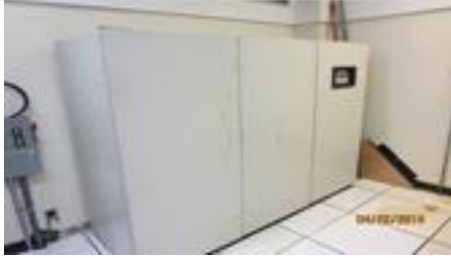
Floor: B1 Room: Main IT Room ID: Type: Air Handling Units	Capital	\$48,803
2015	Necessary	Distribution Systems	Replace

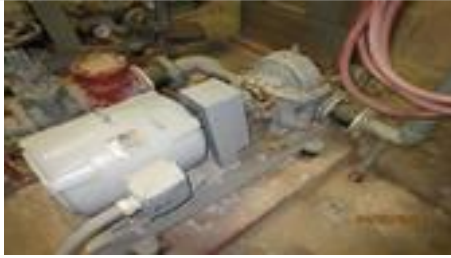
Floor: 10 Room: Council Chambers	Maintenance	\$21,671
2015	Potentially Critical	Domestic Water Distribution	Replace

Floor: B1 Room: Fire Pump Room ID: Type: Domestic Water Pumps	Capital	\$16,234
2015	Potentially Critical	Domestic Water Distribution	Replace

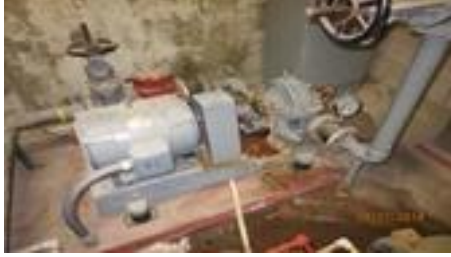
Floor: B1 Room: Fire Pump Room ID: Type: Domestic Water Pumps	Capital	\$16,234

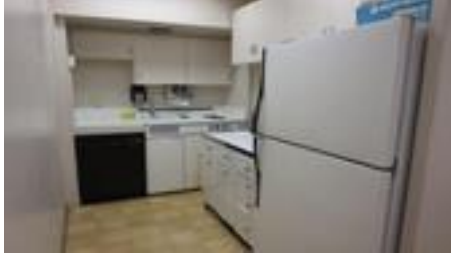
Floor: Roof 1 Room: Penthouse ID: 369796 Type: Exhaust Fans	Capital	\$15,302
2015	Recommended	Other Equipment	Remove and Replace

Floor: 9 Room: Office Kitchenette	Maintenance	\$14,026

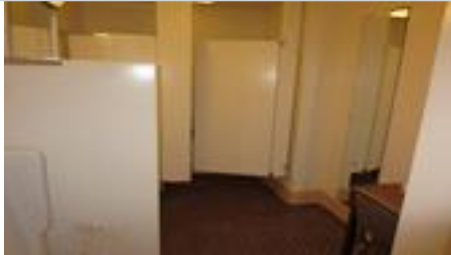
Floor: B1 Room: Fire Pump Room ID: Type: Motor Control Centers	Capital	\$8,755
2015	Recommended	Fittings	Remove and Replace

Floor: 10 Room: Council Chamber Restrooms	Maintenance	\$6,077

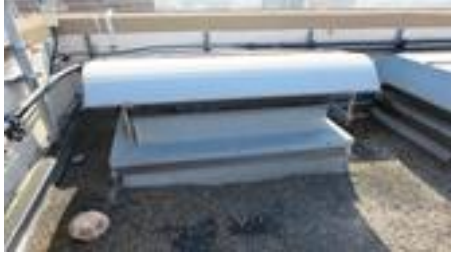
DEFICIENCY REPORT – Building Only							
Year	Priority	Subsystem	Correction	Photo	Location	Funding Type	Cost
2015	Necessary	Distribution Systems	Replace

Floor: Roof 2 Room: Roof 2 ID: Type: Exhaust Fans	Capital	\$4,385
2015	Necessary	Distribution Systems	Replace

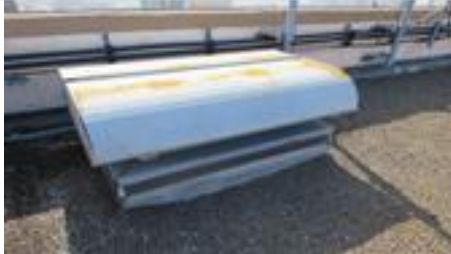
Floor: Roof 2 Room: Roof 2 ID: Type: Exhaust Fans	Capital	\$4,385
2015	Recommended	Other Equipment	Remove and Replace

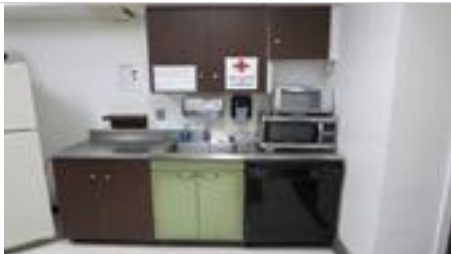
Floor: 3 Room: Office Kitchenette	Maintenance	\$3,259

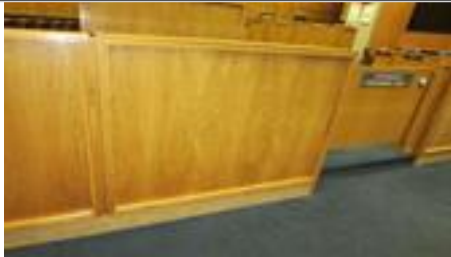
DEFICIENCY REPORT – Building Only							
Year	Priority	Subsystem	Correction	Photo	Location	Funding Type	Cost
2015	Recommended	Wall Finishes	Renew Finishes

Floor: 10 Room: Council Chambers	Maintenance	\$2,700
2015	Recommended	Exterior Windows	Remove and Replace

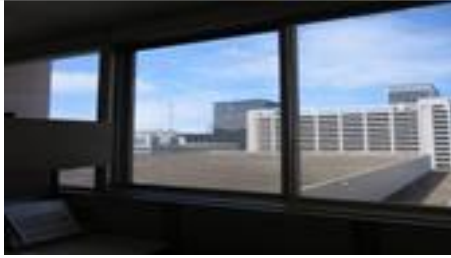
Floor: 10 Room: Office	Maintenance	\$2,186
2015	Recommended	Floor Finishes	Clean

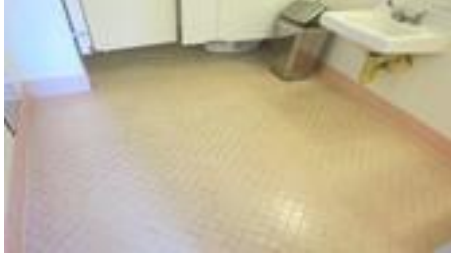
Floor: 10 Room: Council Chamber Restrooms	Maintenance	\$2,079

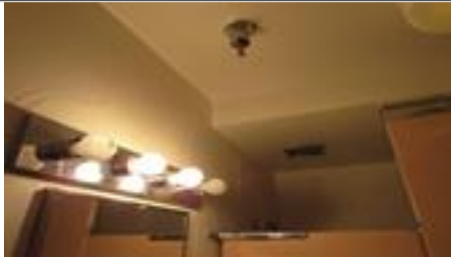
DEFICIENCY REPORT – Building Only							
Year	Priority	Subsystem	Correction	Photo	Location	Funding Type	Cost
2015	Recommended	Wall Finishes	Patch

Floor: 9 Room: Office Restroom	Maintenance	\$1,619
2015	Recommended	Floor Finishes	Clean

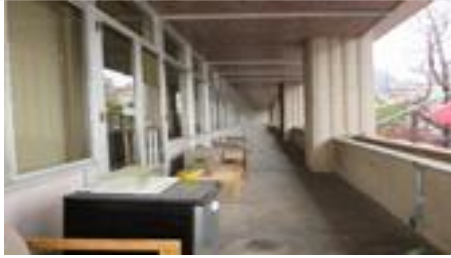
Floor: 1 Room: Balcony	Maintenance	\$1,512
2015	Recommended	Floor Finishes	Remove and Replace

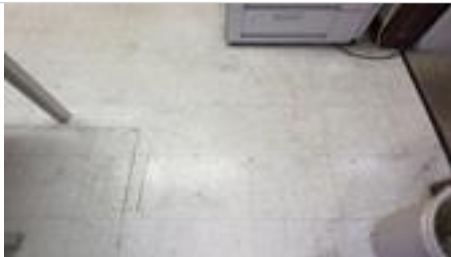
Floor: 7 Room: Office	Maintenance	\$1,334

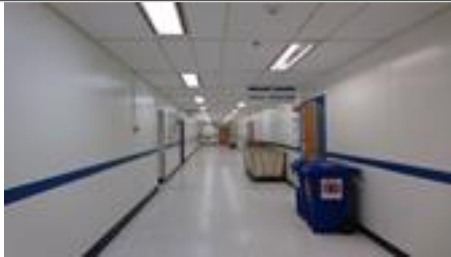
DEFICIENCY REPORT – Building Only							
Year	Priority	Subsystem	Correction	Photo	Location	Funding Type	Cost
2015	Recommended	Floor Finishes	Clean

Floor: B1 Room: Corridors	Maintenance	\$1,170
2015	Recommended	Ceiling Finishes	Repair

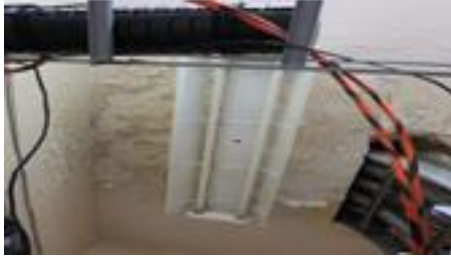
Floor: B1 Room: Data Room	Maintenance	\$1,058
2015	Recommended	Interior Doors	Remove and Replace

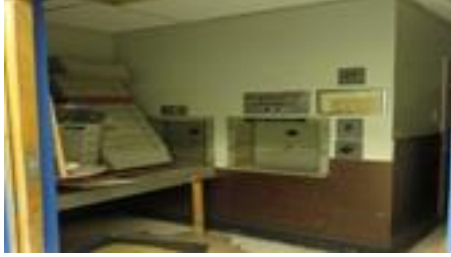
Floor: B1 Room: Corridors	Maintenance	\$999

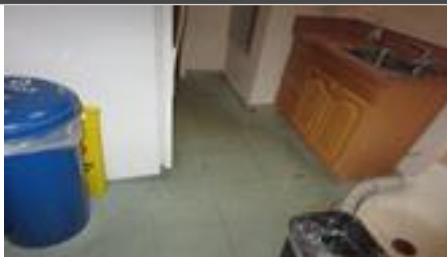
DEFICIENCY REPORT – Building Only							
Year	Priority	Subsystem	Correction	Photo	Location	Funding Type	Cost
2015	Recommended	Floor Finishes	Remove and Replace

Floor: 9 Room: Office	Maintenance	\$931
2015	Recommended	Exterior Walls	Repair

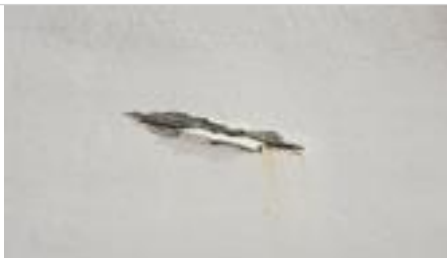
Floor: Roof 1 Room: Mechanical Penthouse	Maintenance	\$752
2015	Recommended	Exterior Windows	Clean

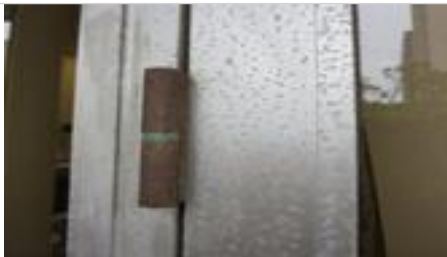
Floor: 2 Room: Office	Maintenance	\$735

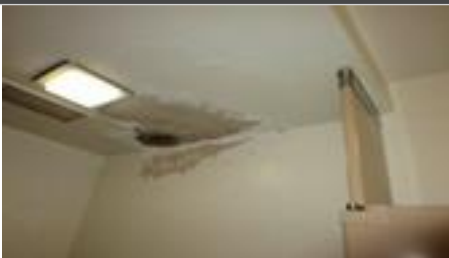
DEFICIENCY REPORT – Building Only							
Year	Priority	Subsystem	Correction	Photo	Location	Funding Type	Cost
2015	Recommended	Wall Finishes	Patch

Floor: 10 Room: Restroom	Maintenance	\$709
2015	Recommended	Wall Finishes	Patch

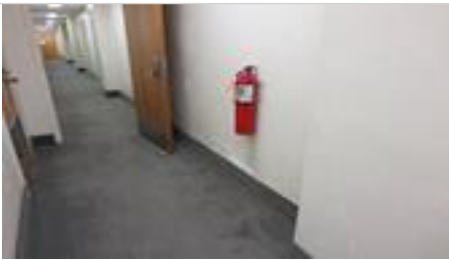
Floor: B1 Room: Corridors	Maintenance	\$484
2015	Recommended	Interior Doors	Renew Finishes

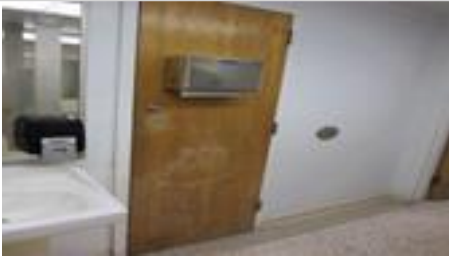
Floor: 2 Room: Womens Restroom	Maintenance	\$464

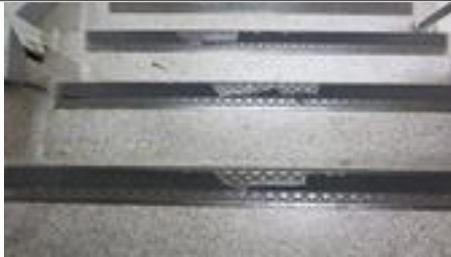
DEFICIENCY REPORT – Building Only							
Year	Priority	Subsystem	Correction	Photo	Location	Funding Type	Cost
2015	Recommended	Stair Finishes	Remove and Replace

Floor: 1 Room: Lobby	Maintenance	\$441
2015	Recommended	Floor Finishes	Repair

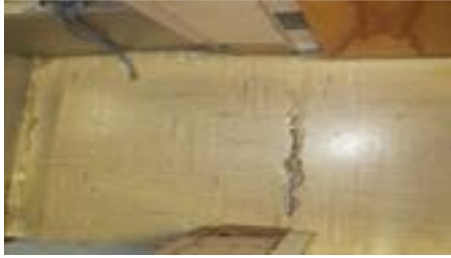
Floor: B1 Room: Data Room	Maintenance	\$370
2016	Potentially Critical	Electrical Service Distribution	Replace

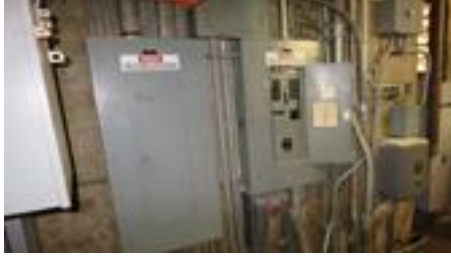
1965 System	Capital	\$6,058,983

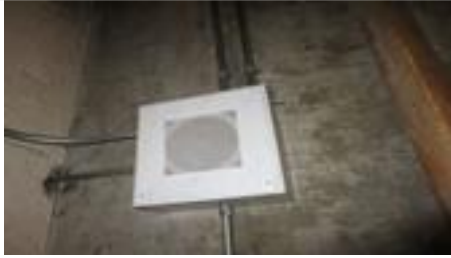
Floor: 10 Room: HVAC Room ID: K30867 Type: Electrical Panel	Capital	\$9,346
2017	Critical	Communications and Security	Replace

1965 System	Capital	\$5,034,106
2019	Recommended	Fittings	Replace

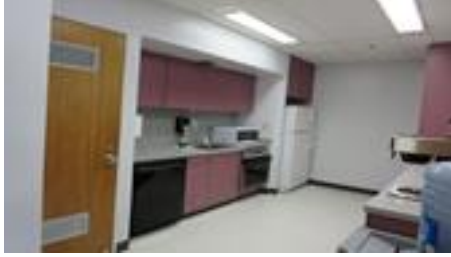
1965 System	Capital	\$1,187,955

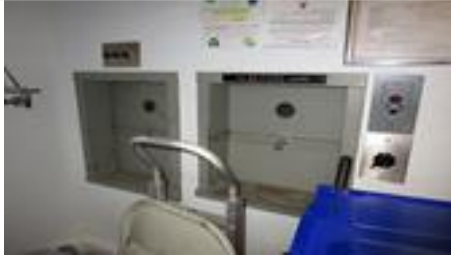
Floor: B1 Room: Fire Pump Room ID: Type: Fire Suppression Valve	Capital	\$7,922
2020	Necessary	Other Conveying Systems	Replace

1965 System	Capital	\$410,860
2022	Potentially Critical	Terminal and Package Units	Replace

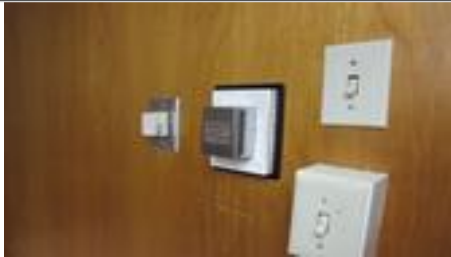
DEFICIENCY REPORT – Building Only							
Year	Priority	Subsystem	Correction	Photo	Location	Funding Type	Cost
2022	Necessary	Controls and Instrumentation	Replace

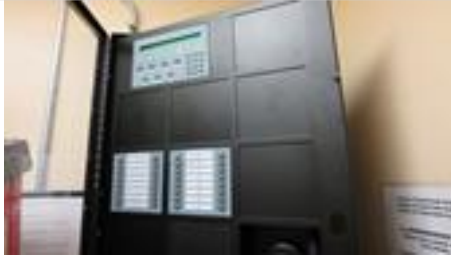
1965 System	Capital	\$4,371,816
2022	Critical	Communications and Security	Replace

Floor: 1 Room: Fac Room ID: Type: Fire Alarm System	Capital	\$19,079
2022	Necessary	Distribution Systems	Replace

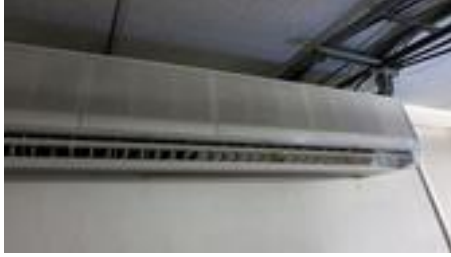
Floor: 10 Room: Data Room ID: 0000871 Type: Fan Coil Units	Capital	\$8,156

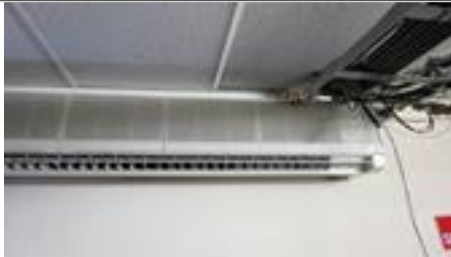
DEFICIENCY REPORT – Building Only							
Year	Priority	Subsystem	Correction	Photo	Location	Funding Type	Cost
2022	Necessary	Distribution Systems	Replace

Floor: 10 Room: Data Room ID: 0104863 Type: Fan Coil Units	Capital	\$8,156
2023	Critical	Other Fire Protection Systems	Replace

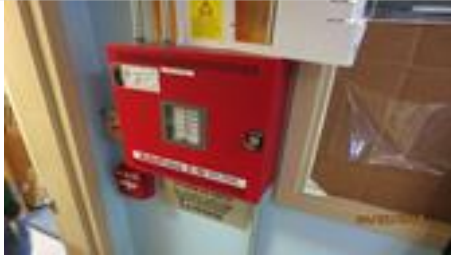
1965 System	Capital	\$294,838
2023	Necessary	Distribution Systems	Replace

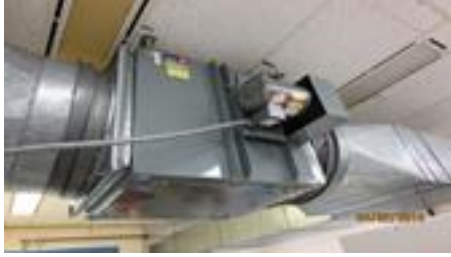
Floor: B1 Room: IT Room ID: Type: Exhaust Fans	Capital	\$12,964

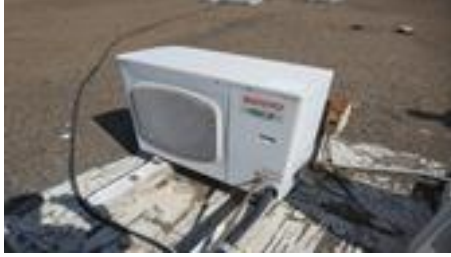
Floor: Roof 1 Room: Roof 1 ID: 0009271 Type: Air Cooled Condensing Units	Capital	\$8,105
2024	Potentially Critical	Terminal and Package Units	Replace

Floor: Roof 1 Room: Roof 1 ID: 0113164 Type: Air Cooled Condensing Units	Capital	\$8,105

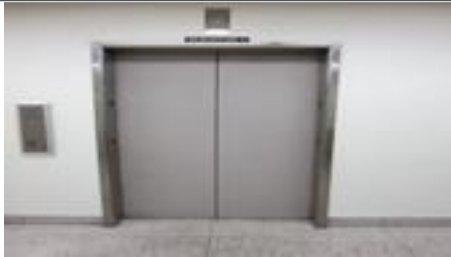
DEFICIENCY REPORT – Building Only							
Year	Priority	Subsystem	Correction	Photo	Location	Funding Type	Cost
2025	Necessary	Elevators and Lifts	Replace

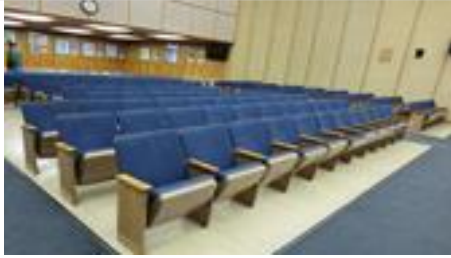
1965 System	Capital	\$14,410,425
2025	Recommended	Fixed Furnishings	Replace

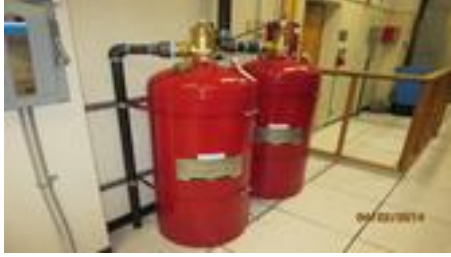
1965 System	Capital	\$1,406,832
2028	Critical	Sprinklers	Replace

Floor: B1 Room: Main IT Room ID: Type: Fire Suppression Pumps	Capital	\$59,216

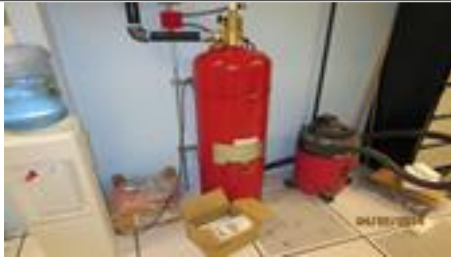
DEFICIENCY REPORT – Building Only							
Year	Priority	Subsystem	Correction	Photo	Location	Funding Type	Cost
2028	Critical	Sprinklers	Replace

Floor: B1 Room: IT Room ID: Type: Fire Suppression Pumps	Capital	\$38,136
2028	Necessary	Distribution Systems	Replace

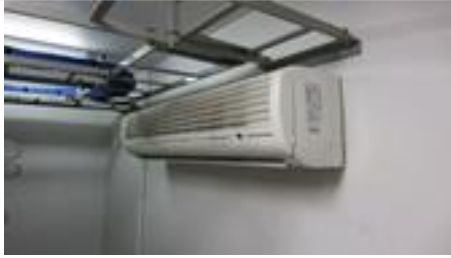
Floor: 6 Room: Data Room ID: Type: Fan Coil Units	Capital	\$7,405
2028	Necessary	Distribution Systems	Replace

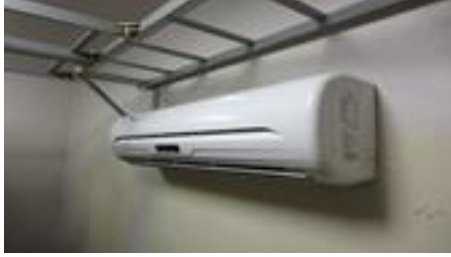
Floor: 9 Room: Data.Phone Room ID: Type: Fan Coil Units	Capital	\$5,453

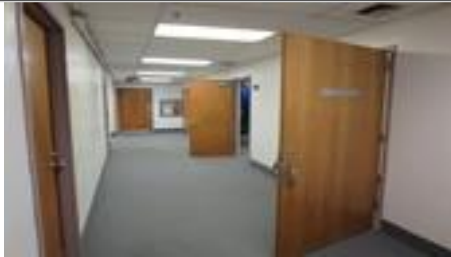
DEFICIENCY REPORT – Building Only							
Year	Priority	Subsystem	Correction	Photo	Location	Funding Type	Cost
2030	Necessary	Lighting and Branch Wiring	Replace

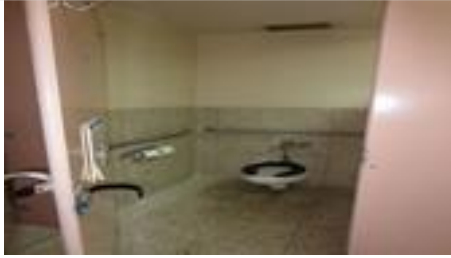
1965 System	Capital	\$30,125,695
2030	Necessary	Plumbing Fixtures	Replace

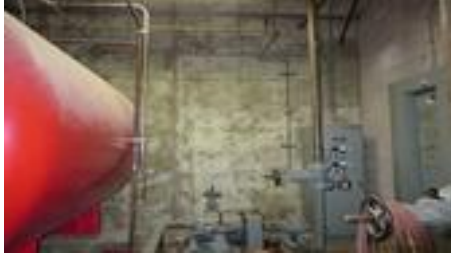
1965 System	Capital	\$9,360,863
2030	Potentially Critical	Heat Generating Systems	Replace

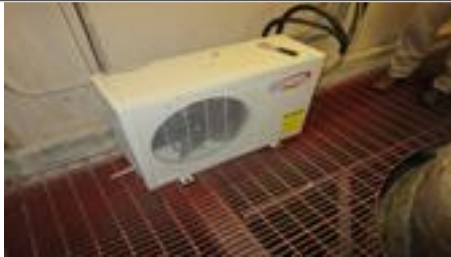
DEFICIENCY REPORT – Building Only							
Year	Priority	Subsystem	Correction	Photo	Location	Funding Type	Cost
2030	Potentially Critical	Terminal and Package Units	Replace

Floor: 9 Room: Plenum Chase ID: Type: Air Cooled Condensing Units	Capital	\$6,930
2030	Potentially Critical	Terminal and Package Units	Replace

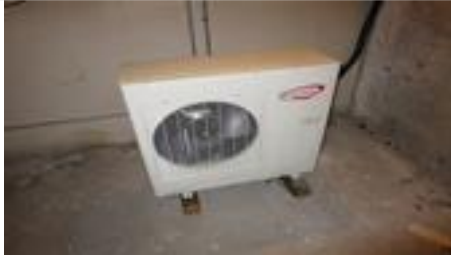
Floor: 6 Room: Plenum Chase ID: Type: Air Cooled Condensing Units	Capital	\$6,930
2034	Critical	Sprinklers	Replace

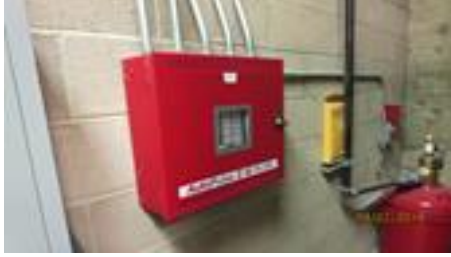
Floor: B1 Room: Electrical Switch Gear ID: Type: Fire Suppression Pumps	Capital	\$8,755

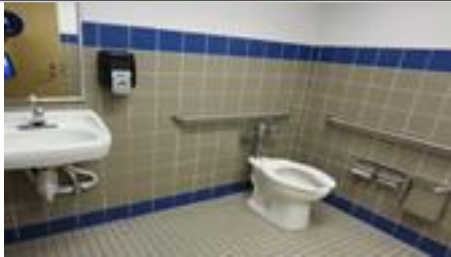
DEFICIENCY REPORT – Site Only							
Year	Priority	Subsystem	Correction	Photo	Location	Funding Type	Cost
2015	Recommended	Sanitary Sewer	Replace

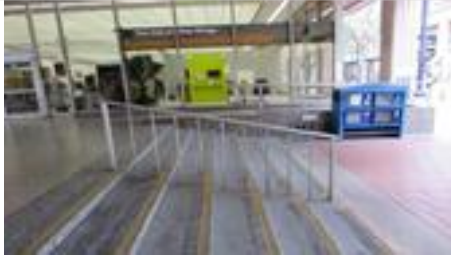
1965 System	Capital	\$277,704
2015	Recommended	Site Development	Replace

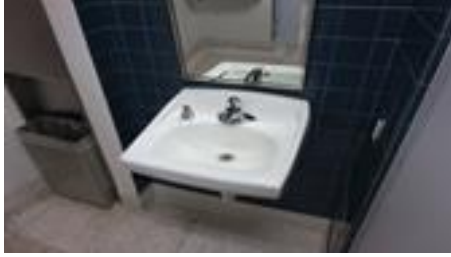
1965 System	Capital	\$242,717
2015	Recommended	Water Supply	Replace

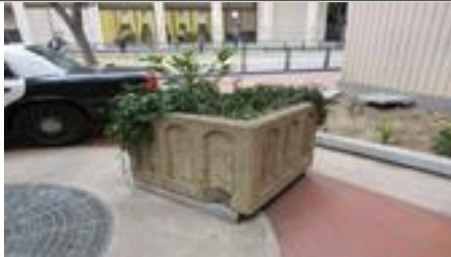
DEFICIENCY REPORT – Site Only							
Year	Priority	Subsystem	Correction	Photo	Location	Funding Type	Cost
2015	Recommended	Landscaping	Replace

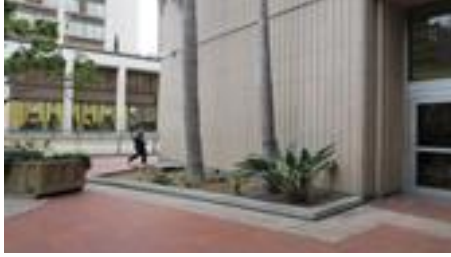
1965 System	Capital	\$101,819
2015	Recommended	Pedestrian Paving	Remove and Replace

Floor: 1 Room: Exterior	Maintenance	\$3,561
2015	Recommended	Landscaping	Remove and Replace

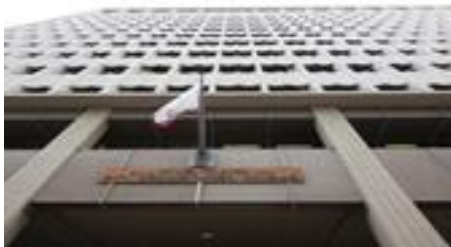
DEFICIENCY REPORT – Site Only							
Year	Priority	Subsystem	Correction	Photo	Location	Funding Type	Cost
2015	Recommended	Site Development	Clean

Floor: 1 Room: Exterior	Maintenance	\$604
2025	Recommended	Site Lighting	Replace
